Site Inspection Report

Dinah Beach Cruising Yacht Association

23 June 2022

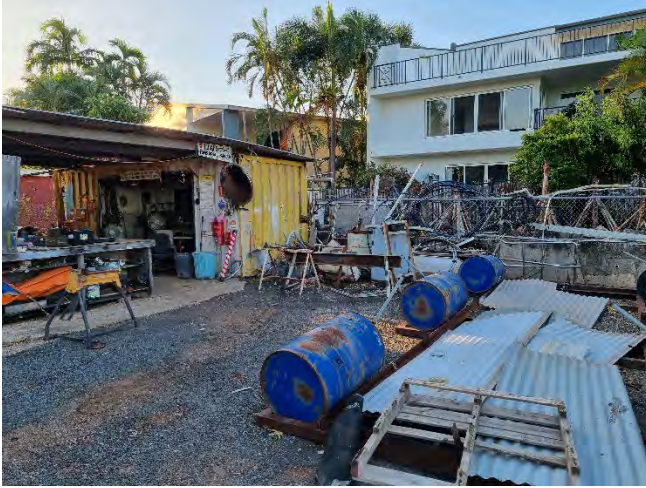
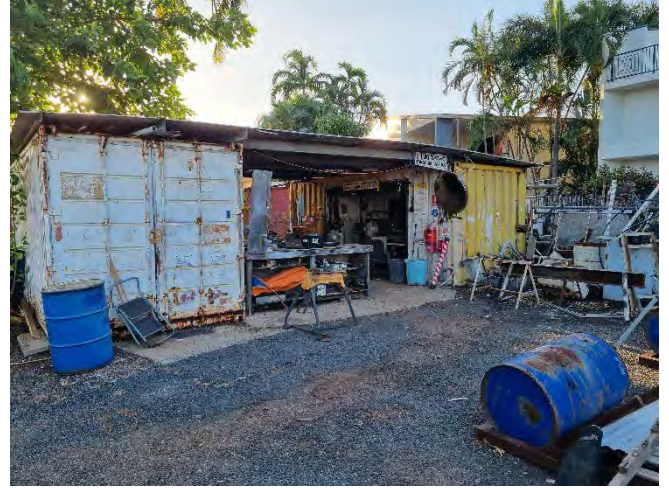
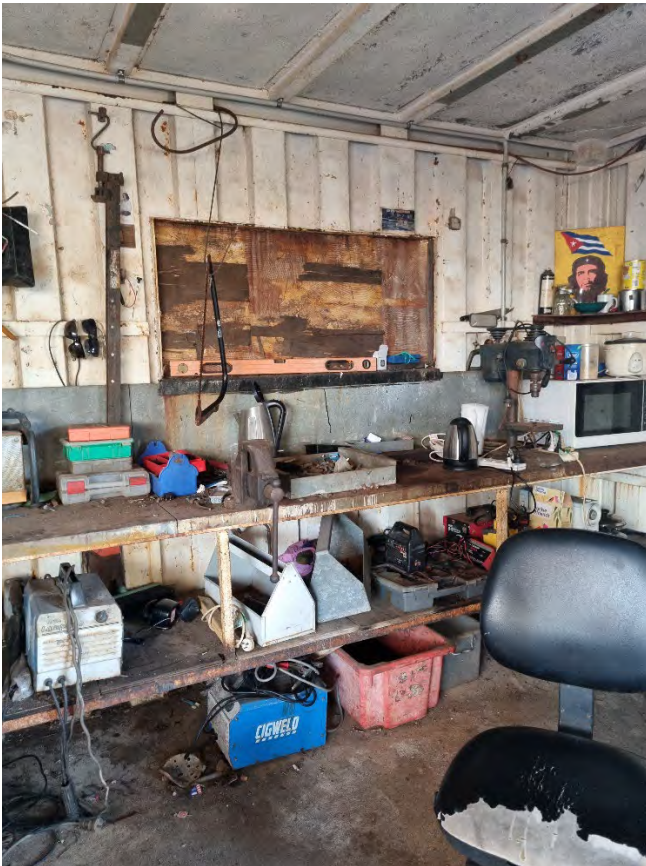
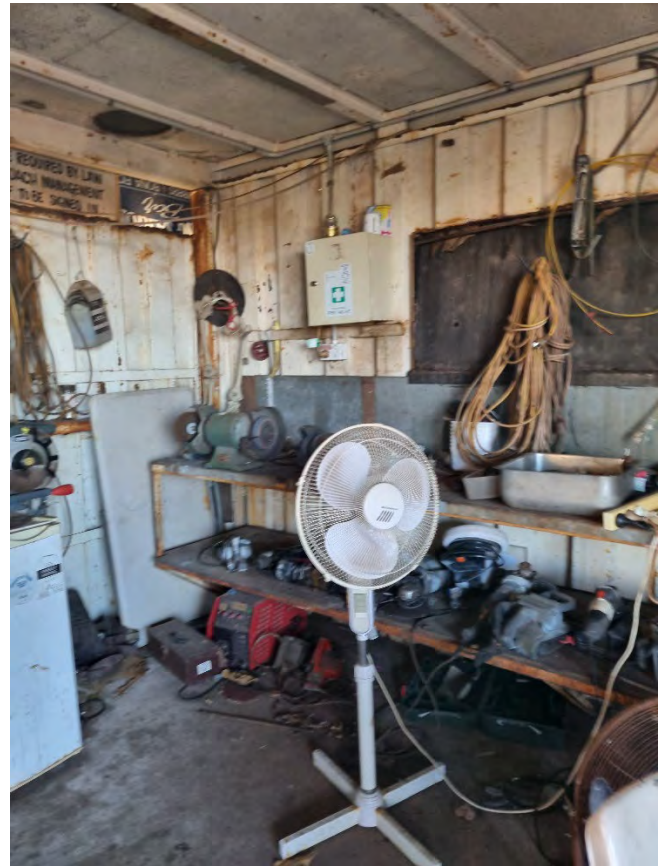
Table 1 Workshop

- Access to the site is unrestricted, as such it does present a safety concern for general patrons of the facility, including children.
- Designation of use and areas unclear.
- As part of the shared material/parts systems, there is material left with little or no understanding of its usefulness or owner.
- The two existing shipping containers are in poor condition.

- A physical barrier and/or fence and gate installed to limit access to the public.
- Increased education to Club members such they are aware of the consideration of use and safety considerations for the Workshop Facility.
- Increased and compliant signage to assist with designation of hazardous/flammable goods areas (solvents and paints etc), hot work areas, tool storage, general working and storage areas.
- Development of, education and implementation of governance around the use of the facility. This should include:
 - Storage and use of solvents and paints
 - Leaving and usage of items left in the shared area.
 - Weekly or fortnightly clean and check of equipment.
- Long term solution is to replace the existing shipping containers and provide a load-supporting shade structure

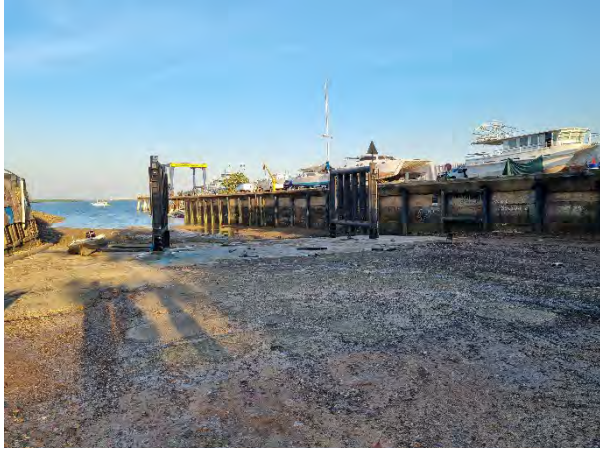
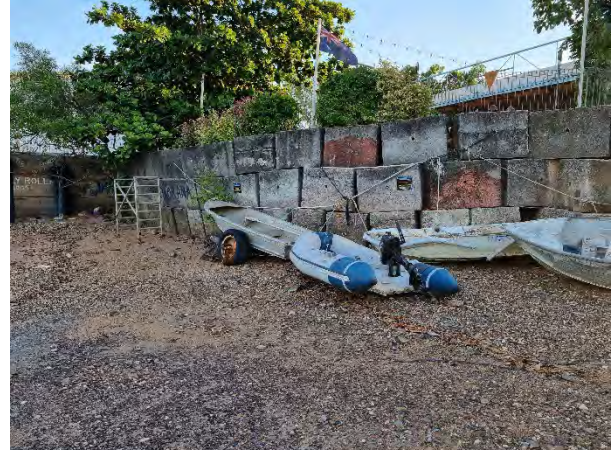
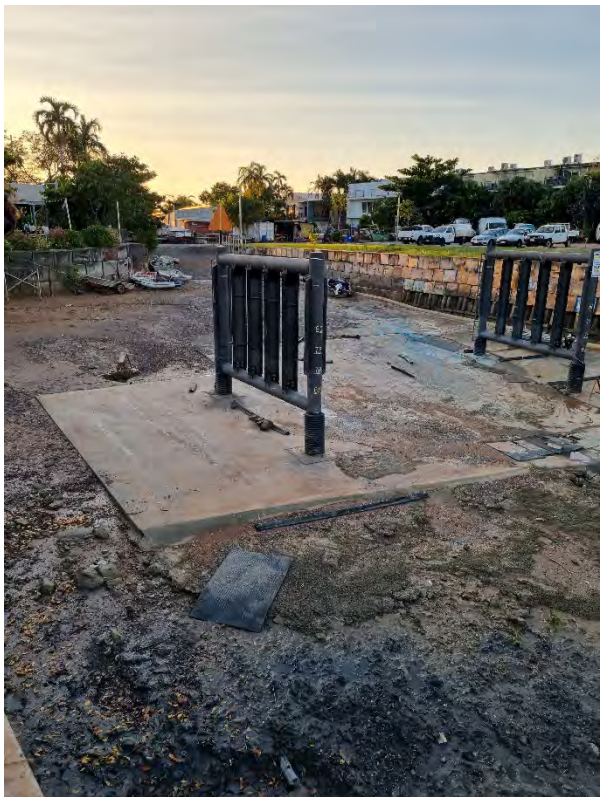
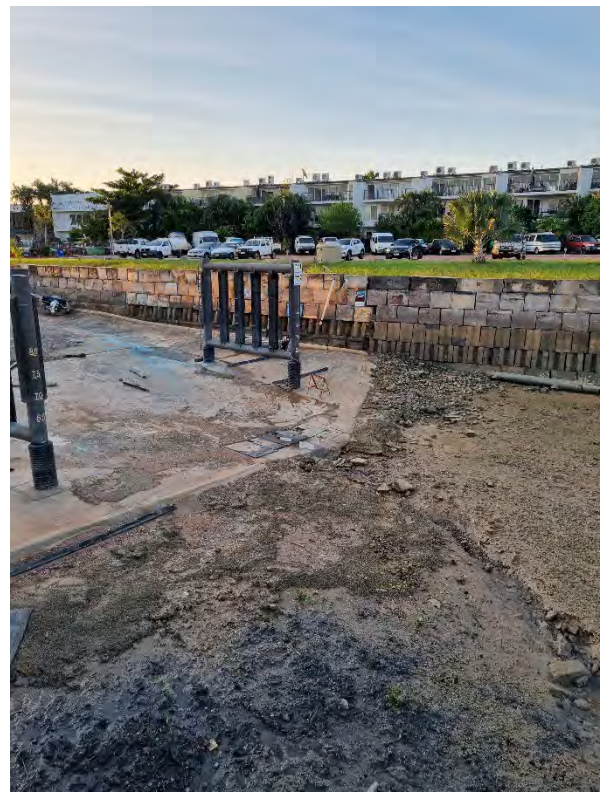
Table 2 *Boat Ramp and Berthing*

The mooring pylons have recently been “refurbished” and in serviceable condition.

The wharf structure has never been certified and construction details are not available. The crane operators currently make their own call about how close to the edge of the platform to make a lift. The potential total lift mass may exceed 150 t.

Boat ramp eastern wall is progressively subsiding towards the water line. The wall is constructed of large concrete blocks, each approximately 2.4 m in height. This wall retains the filled area used as the alfresco dining area. A design has been previously completed by a member of the Club, however at time of inspection unclear of the standard and also overall usability. No documentation exists for the original wall design or construction. The wall is located close to a tree of significance

The boat ramp area has irregular portions of concrete laid in order to increase the serviceability of the boat ramp, however the placement has been piecemeal and elements such as reinforcing, dowling between sections and reinforcing steel coverage are not known.

- The alfresco dining area retaining wall design be reviewed for functionality requirements by the Club, to refine the needs and constraints.
- Following confirmation of the retaining wall requirements, a re-design of the wall be undertaken, followed by market testing to understand budgetary needs for removal of the old wall and construction of the new wall.
- The concrete treatment be replaced with a purpose-designed boat ramp, complete with anti-slip/skid treatment for vehicular use.

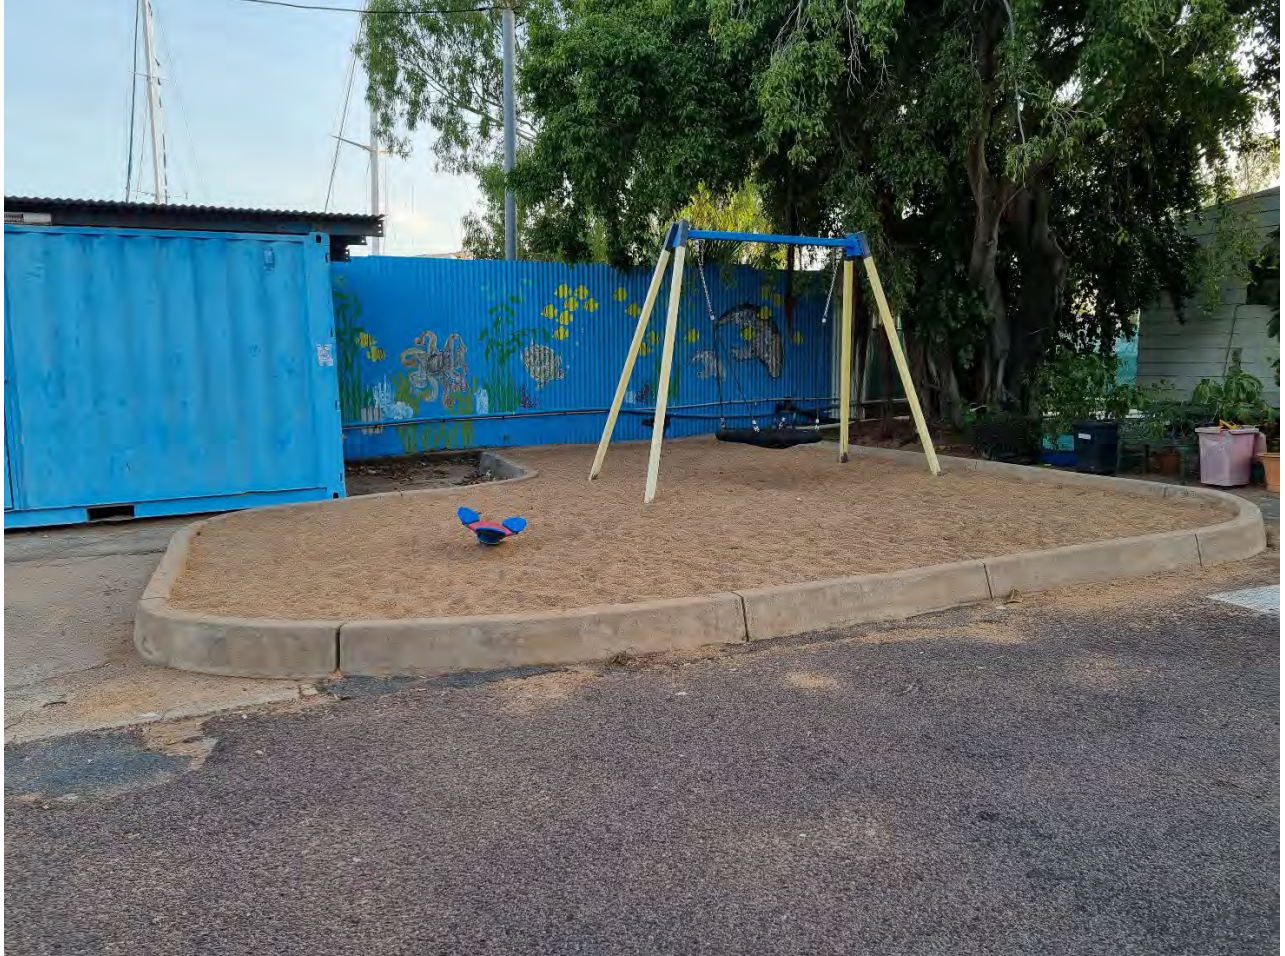
Table 3 *Children's Playground*

At time of inspection, it is not clear if the playground complies with relevant standards.

It is proposed that the Club undertake an upgrade to the children's playground to improve the patron experience.

Compliance with relevant Australian Standards can be achieved through the sourcing the playground through a suitable proprietary vendor.

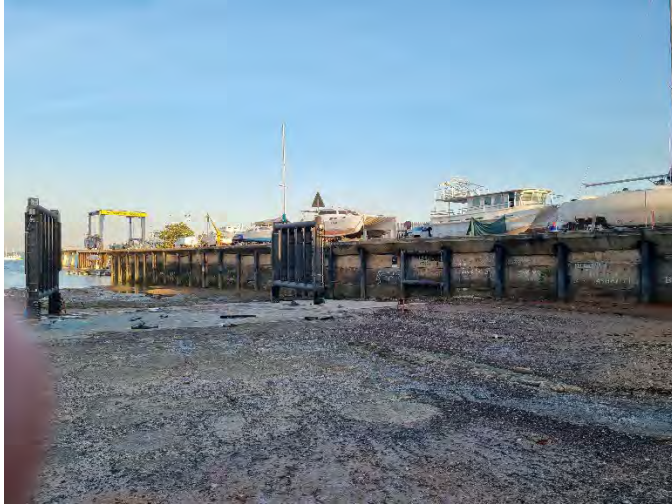
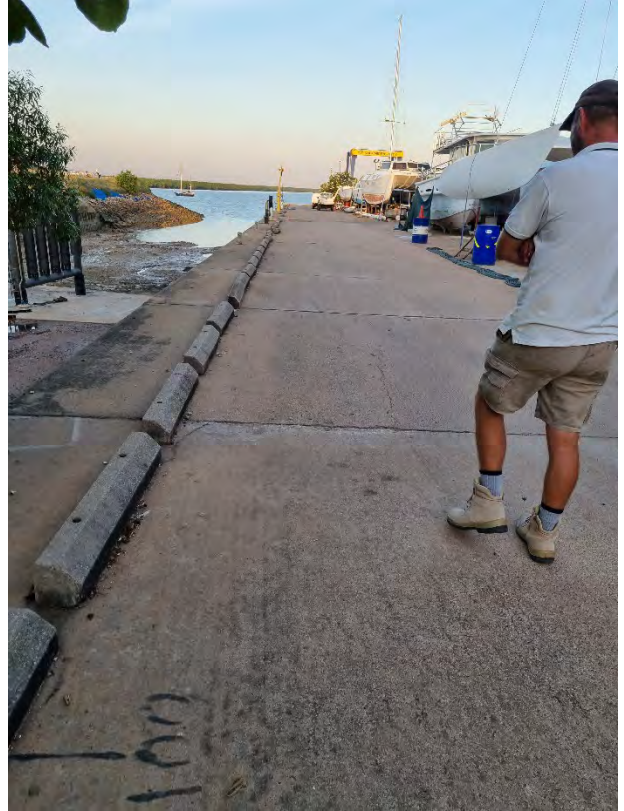
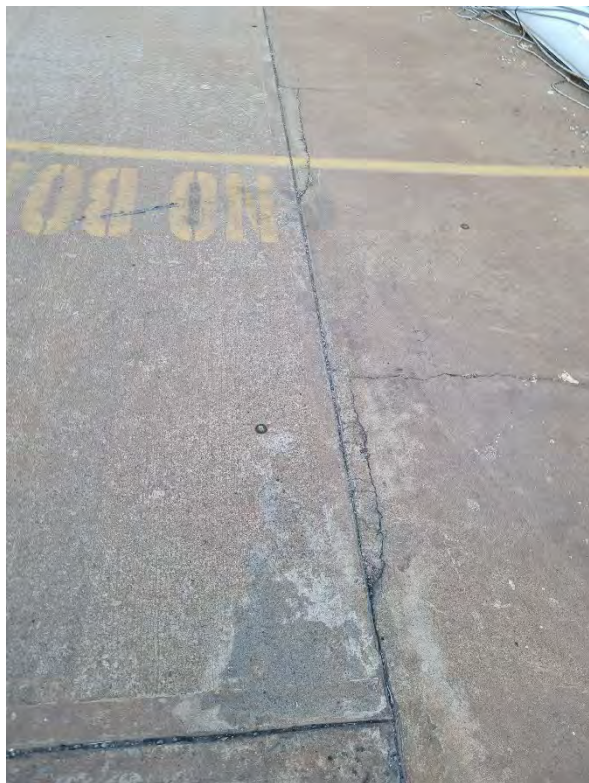
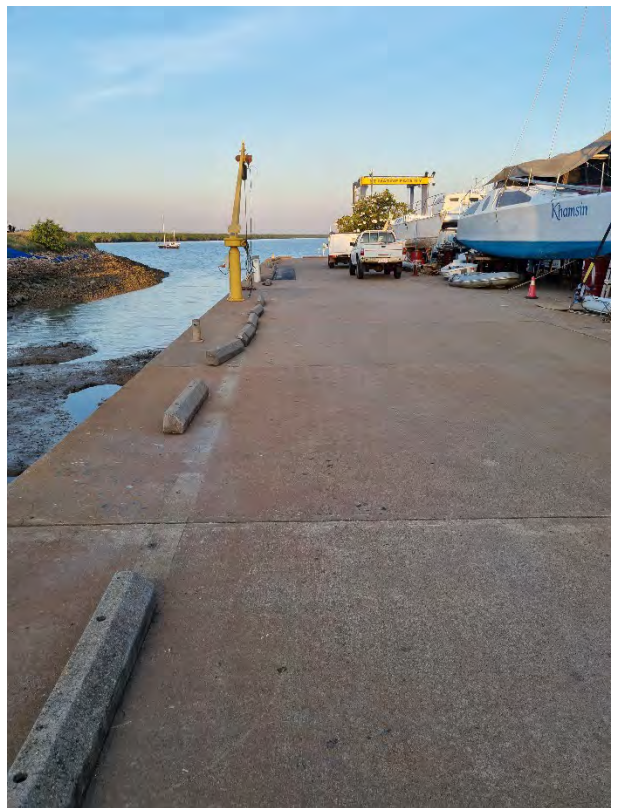
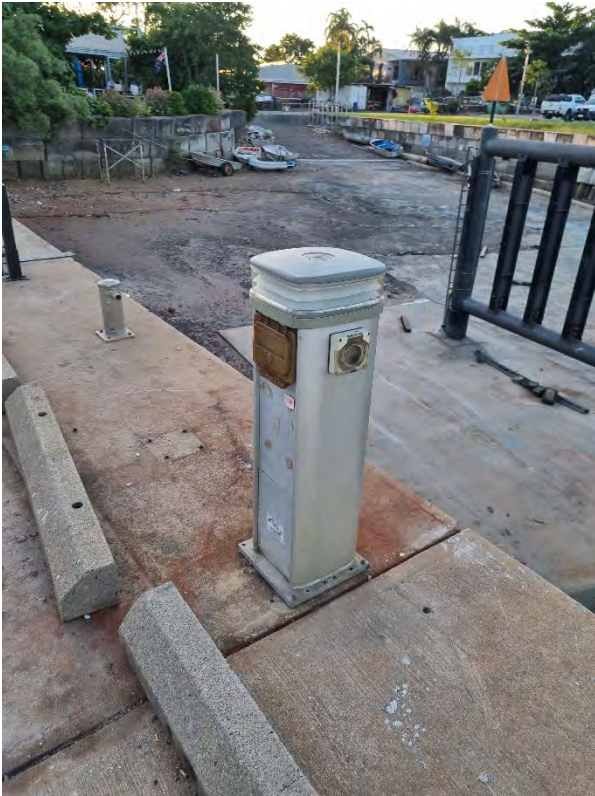
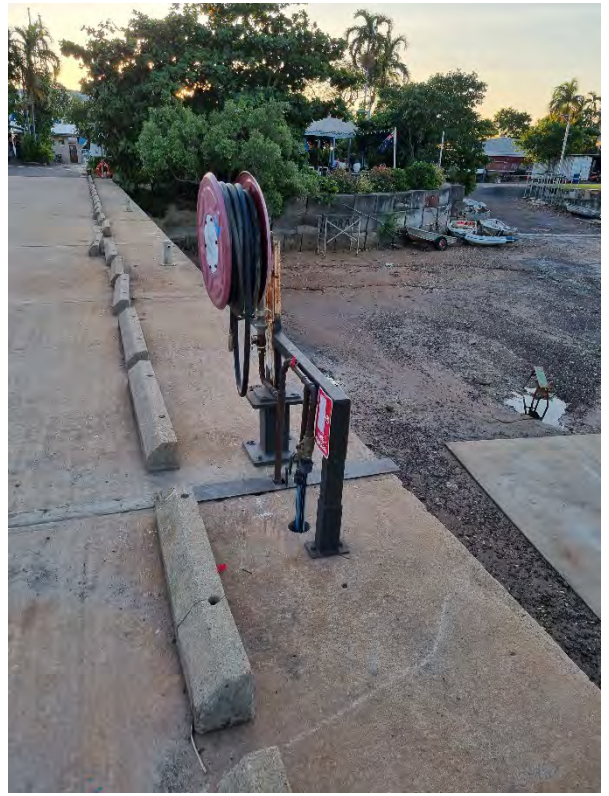
Table 4 Concrete Wharf

- Little obvious designation was noted for activities such as lift zones, pedestrian movement, crane limits, emergency response gear (fire hydrant/s)
- Climbing ladders, wheel stops, and bollards don't appear fit-for-purpose
- There appears to be some longitudinal cracking and some very early evidence of concrete spalling in the concrete slabs.

- A further detailed people/safety compliance review be undertaken to identify for rectification those personnel safety items in order to minimise Club liability.
- General signage and line-marking improvements
- Replacement of the access ladders
- Suggest inspection by structural engineer be undertaken then potential additional investigation activities for the purpose of self-informing (not certification) could include:
 - Ground penetrating radar (quite cheap) to inform where low densities (cavities) may or may not exist
 - Survey surface (baseline for monitoring) and installation of movement gauges
 - More destructive investigation (core-drilling etc):
 - This process is unlikely to lead to a certification and is more a self-assurance outcome for the Club

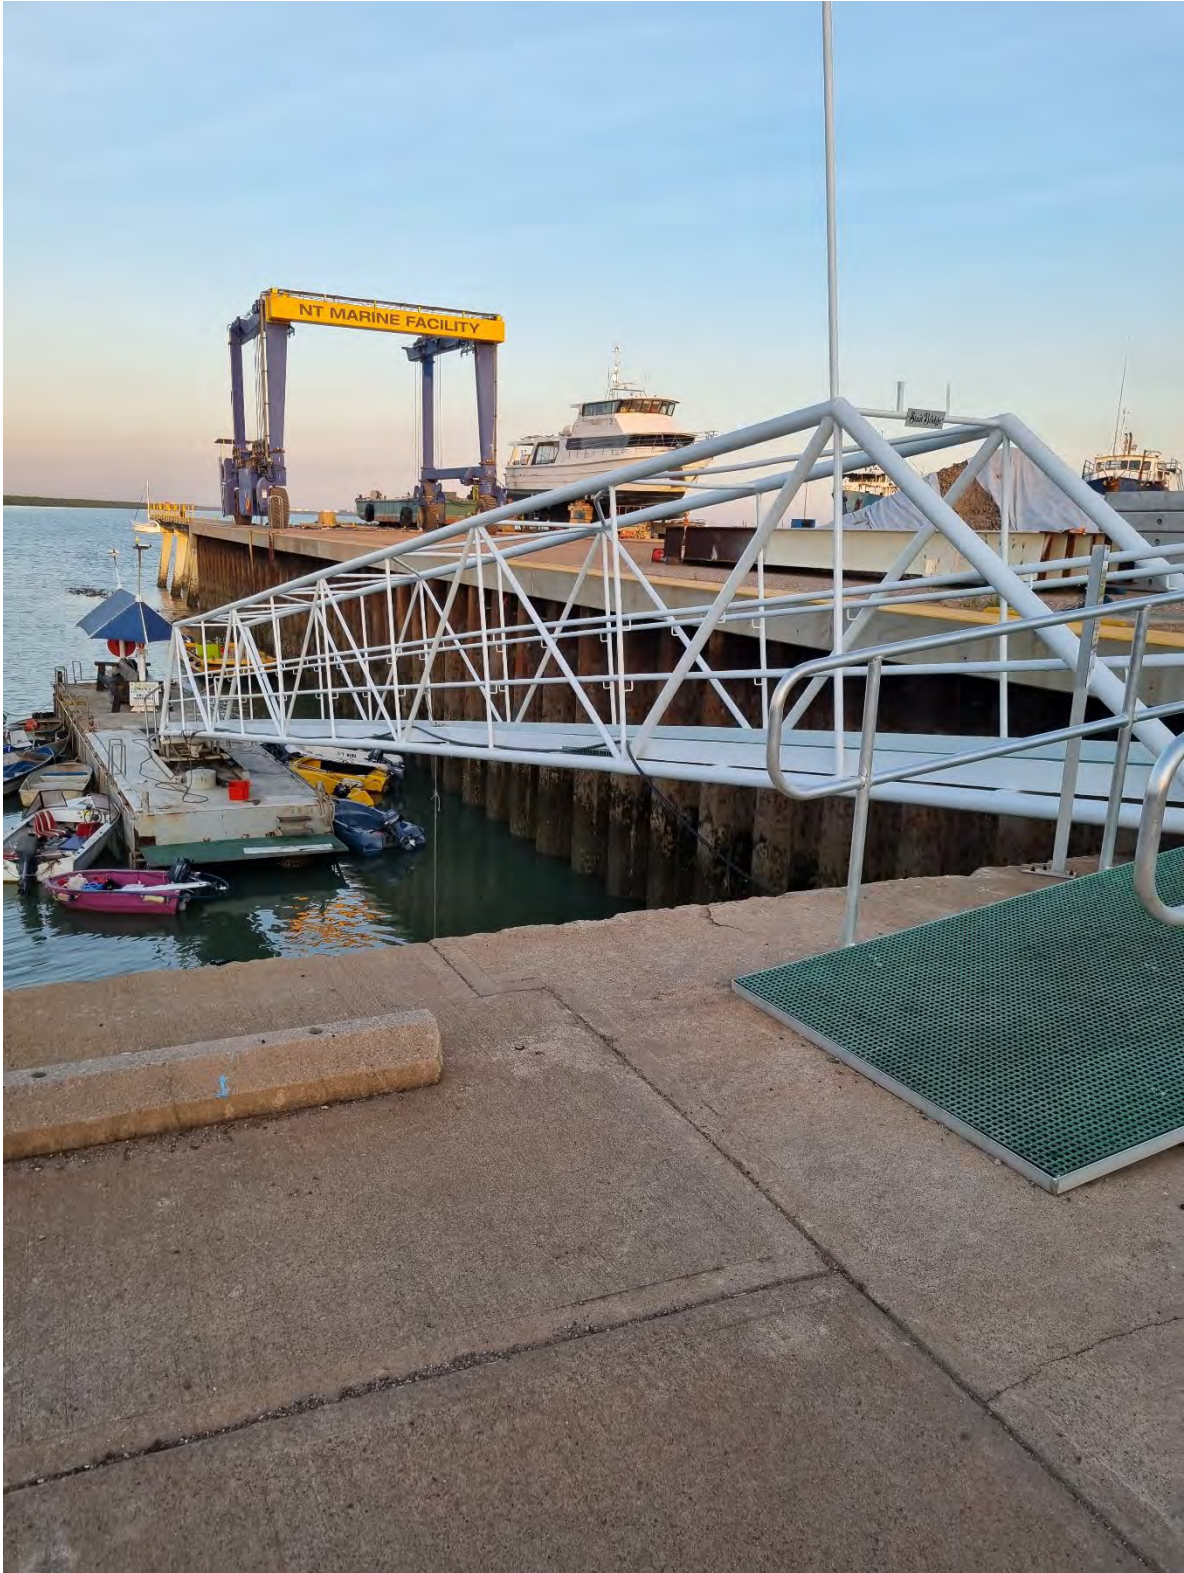
Table 5 Pontoon

It appeared that there were conflicting views on the usability of the pontoon system through tidal movements and possibility of siltation incrementally reducing access for users.

- A detailed survey of the usability be undertaken with pontoon users to consolidate relevant themes to inform a forward plan of works.
- Rudimentary bathymetric measurements be undertaken to understand extent of siltation.
- Engagement of a suitable marine engineer to assess, scope and cost the replacement of the pontoons.

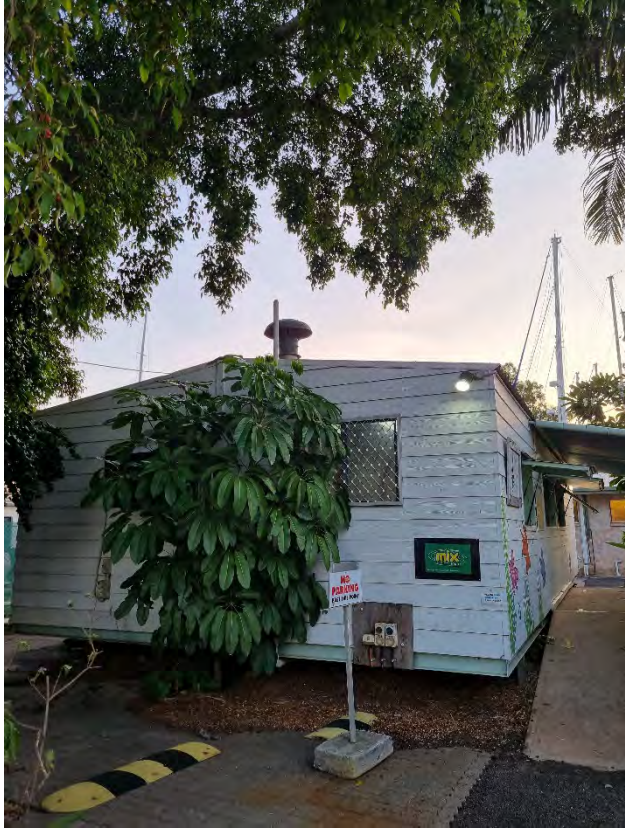
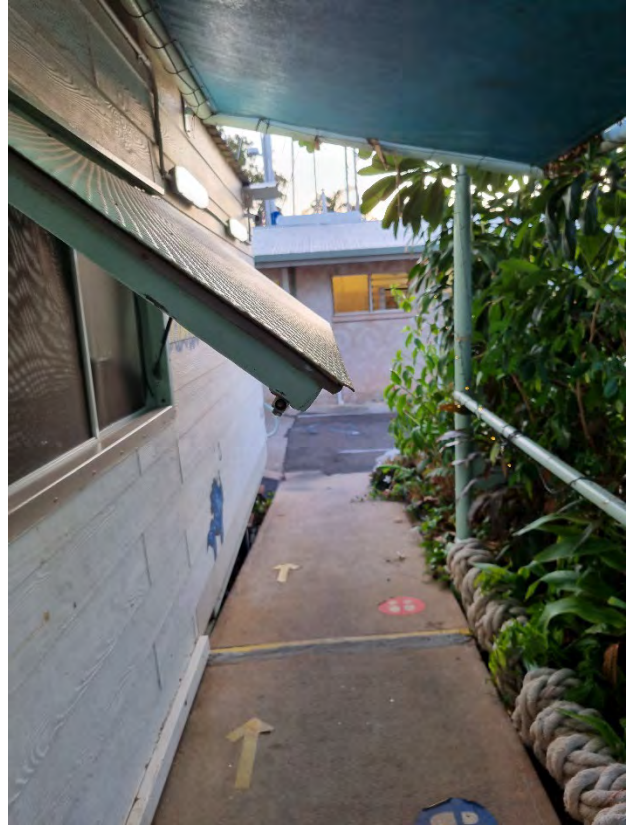
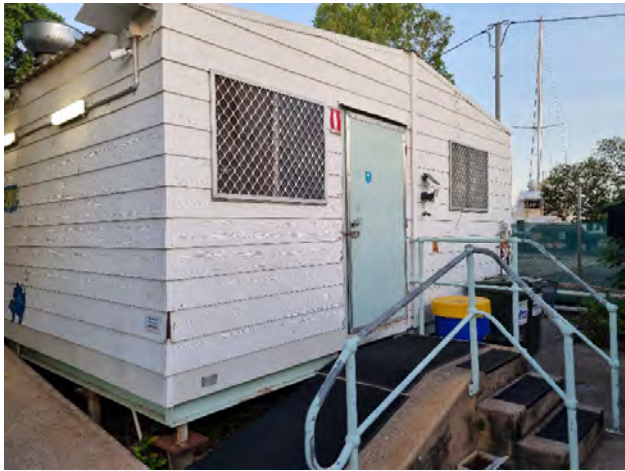
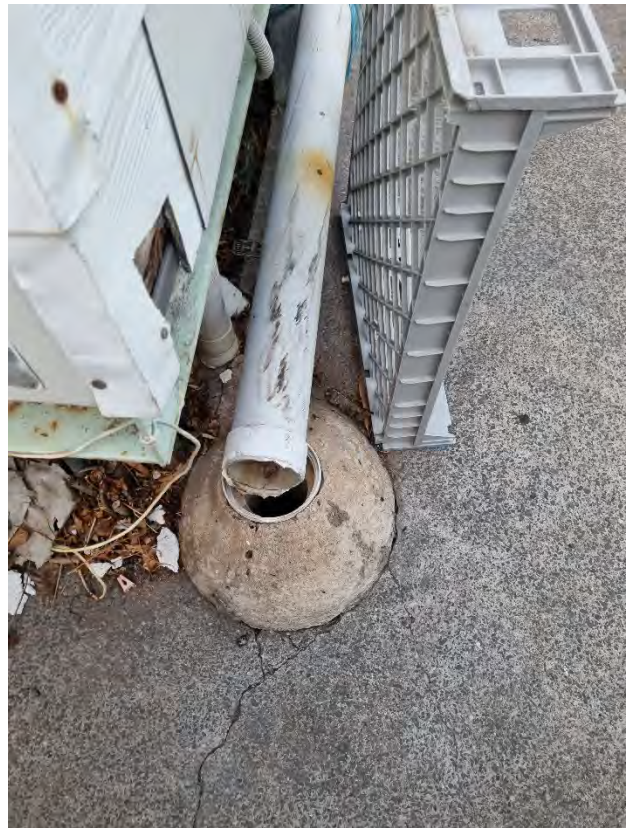
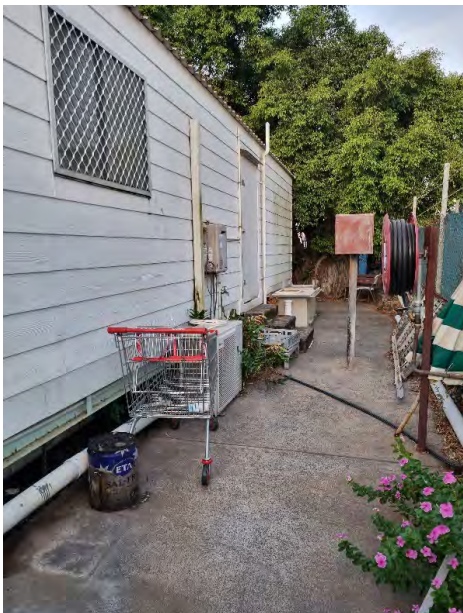
Table 6 Kitchen

The internal aspects of the facility were not inspected during the site visit, however externally the building looks a poor condition and unlikely to meet safety compliance standards.

Access to the kitchen would not comply with disabled access standards and patron safety is at risk with the low-mounted awnings along the access pathway.

The kitchen presents an uncovered path between the alfresco eating area and the point of meal collection, creating a less comfortable patron experience during the wet season.

It is recommended that the kitchen undergo an architectural and building code compliance assessment, after which the Club can determine appropriate next steps, timing and costs.

Whilst clearly the facility is serving a purpose currently, it is very likely that a full replacement of the facility will be required in the medium term.

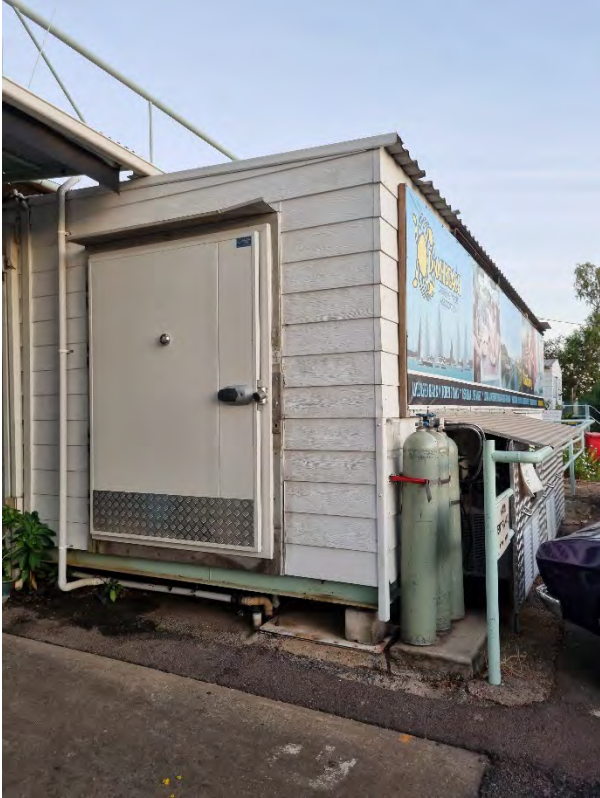
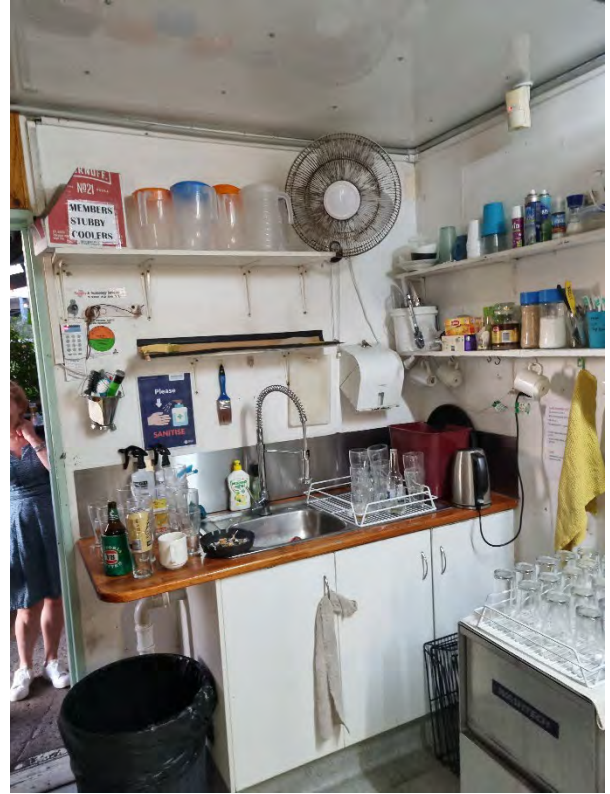
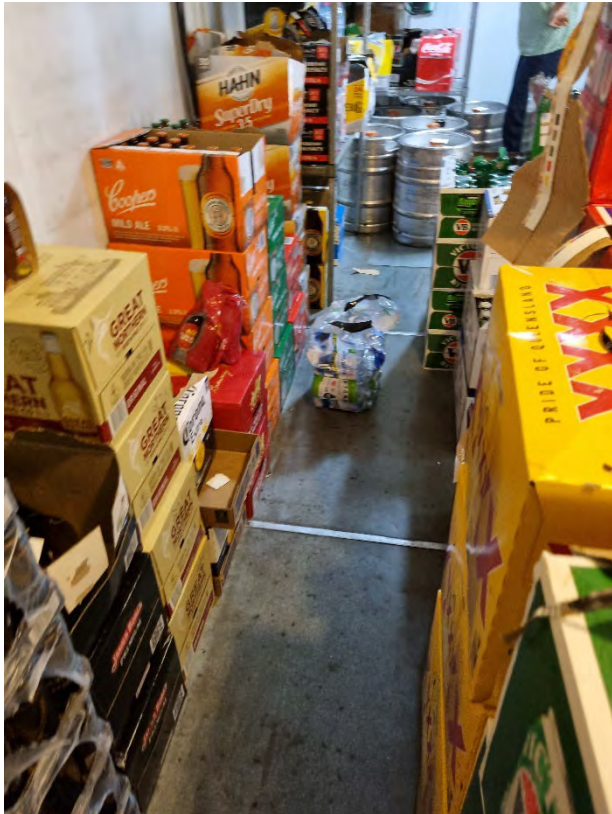
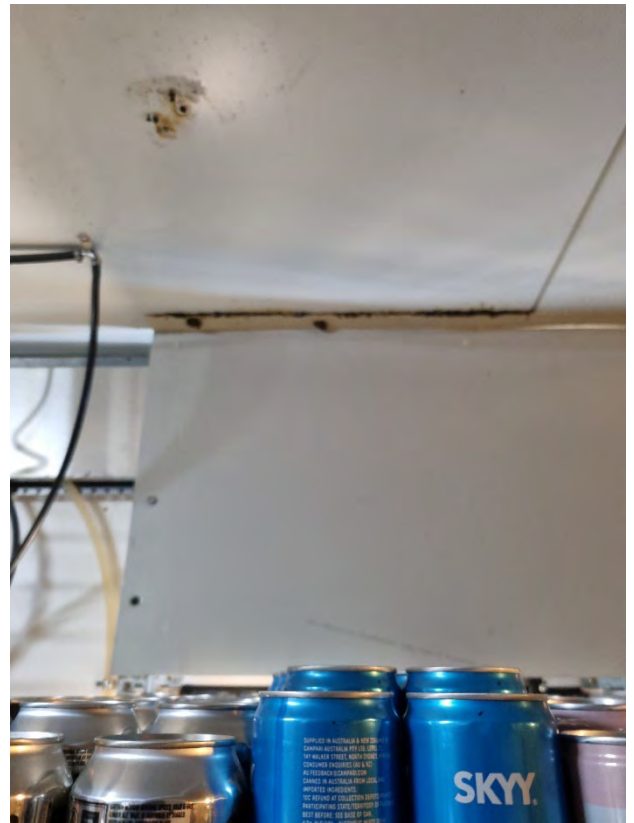
Table 7 Bar and Alfresco Area

The bar, cold storage and alfresco dining area provide a coastal, rustic feel to the patrons. The elements reflect the development of the area in stages, with perhaps less consideration of the overall planning, functionality and flow of the facility for employees and patrons.

- Complete a detailed architectural and building code compliance review of the facilities.
- Quote and subsequent replacement of the cool room flooring.

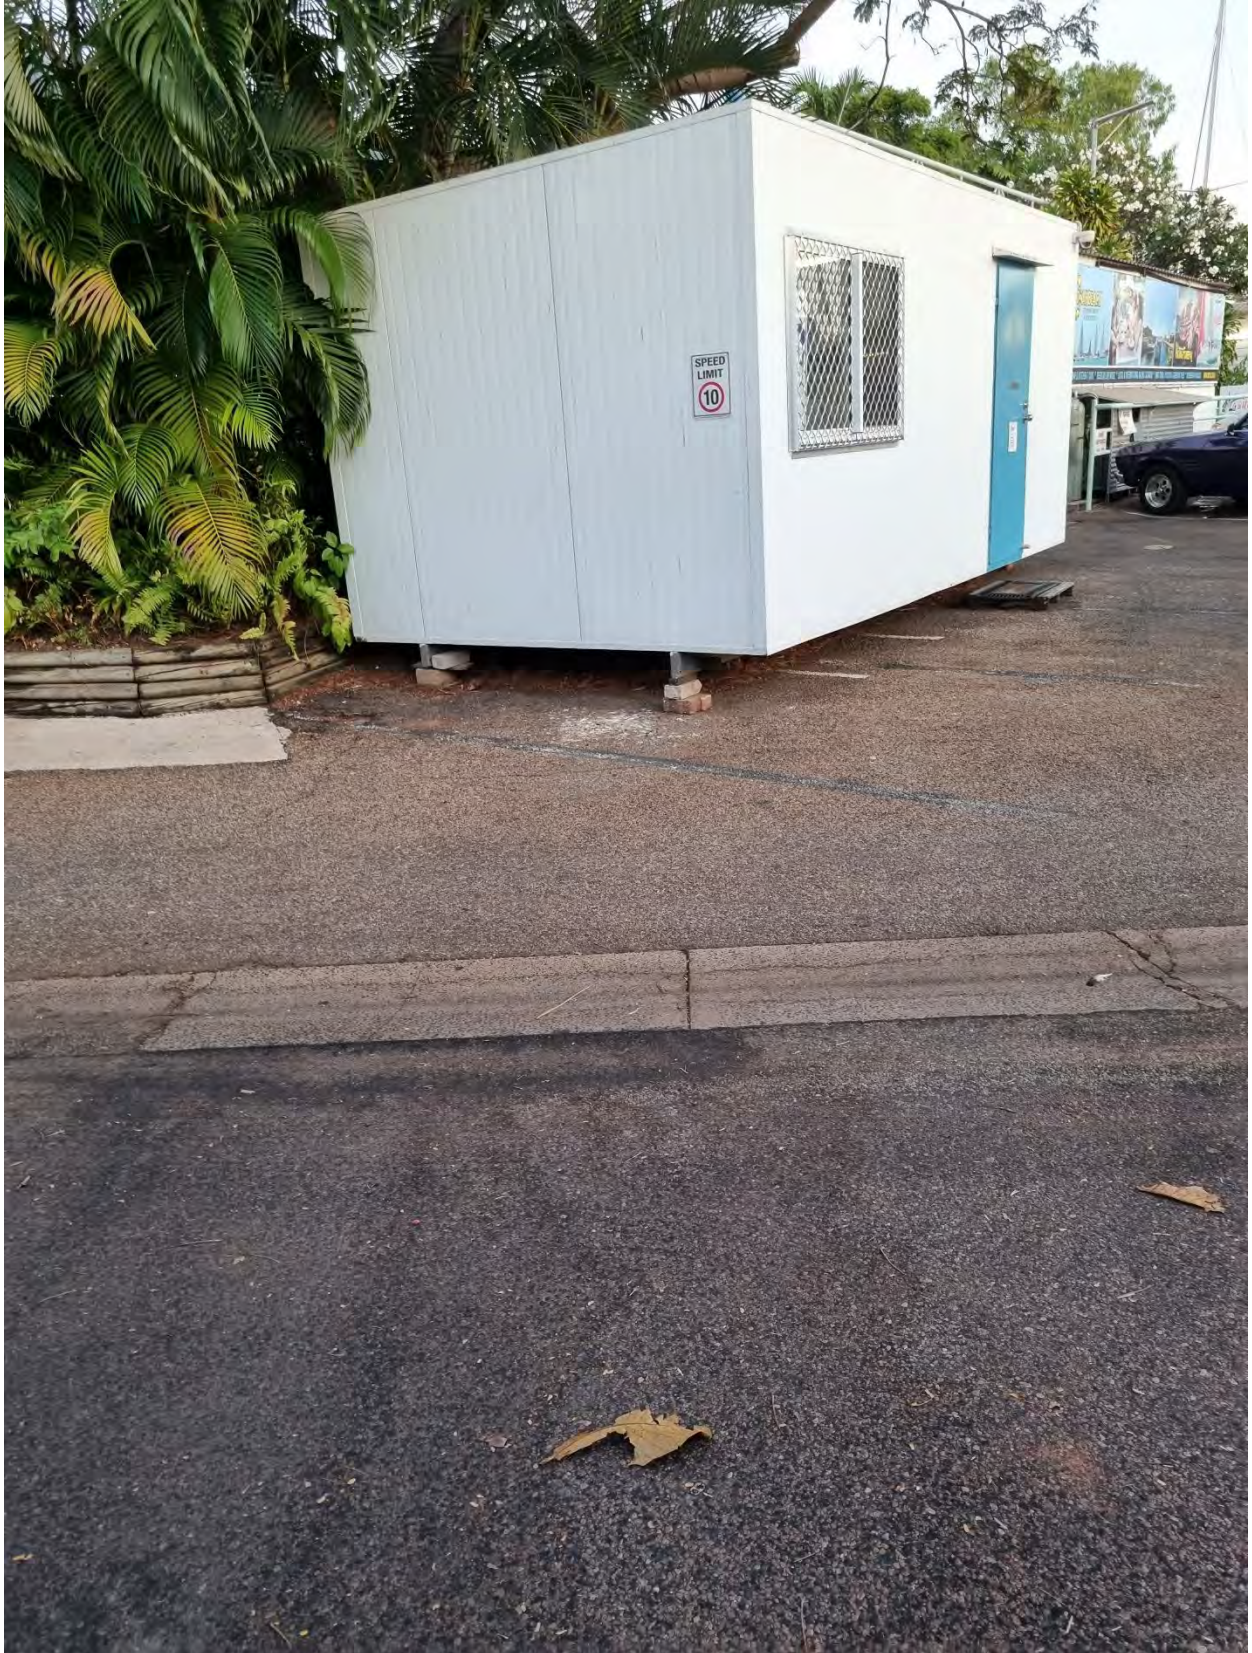
Table 8 Office

The office is not fixed securely and would be susceptible to movement in the event of strong winds.

The entry/exit is via a door without landing or compliant steps.

- Relocation of the office to the current location of the kitchen.
- Securing of the office using proprietary portable footings
- Manufacture and installation of a compliant landing/stairs to the office access.
