Site Inspection Report

Dinah Beach Cruising Yacht Association

23 June 2022

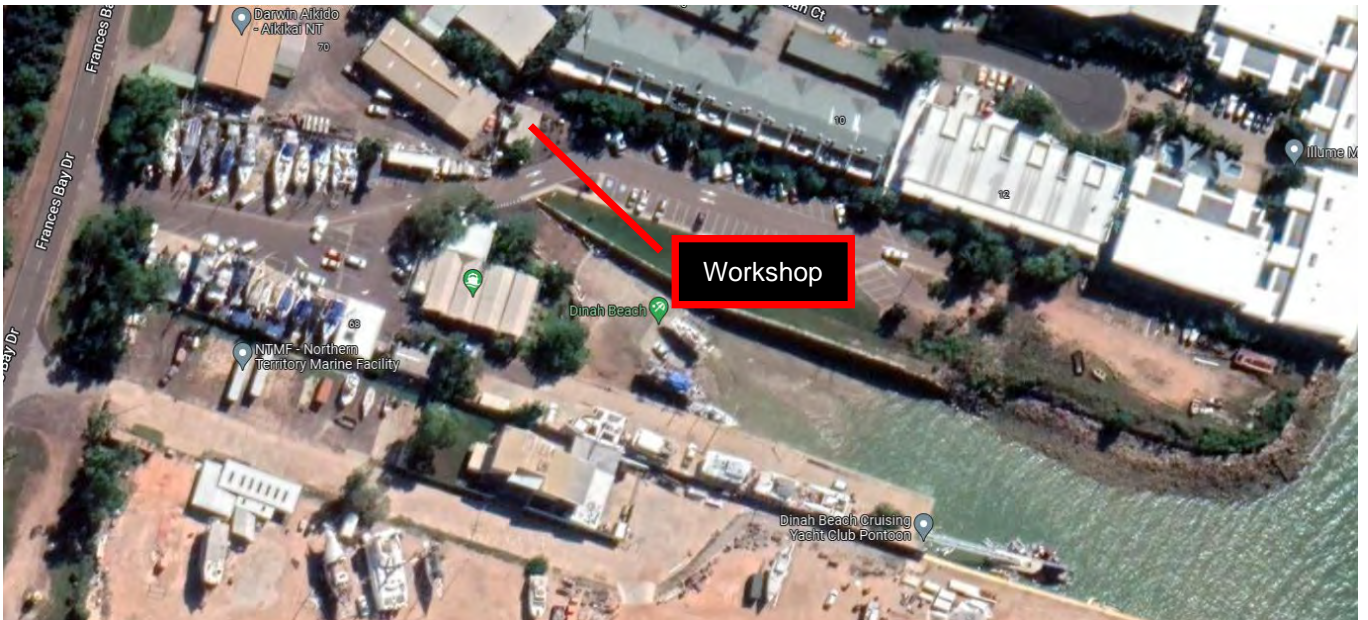
Figure 1 Workshop Location

- Access to the site is unrestricted, as such it does present a safety concern for general patrons of the facility, including children.
- Designation of use and areas unclear.
- As part of the shared material/parts systems, there is material left with little or no understanding of its usefulness or owner.
- The two existing shipping containers are in poor condition.

- A physical barrier and/or fence and gate installed to limit access to the public.
- Increased education to Club members such they are aware of the consideration of use and safety considerations for the Workshop Facility.
- Increased and compliant signage to assist with designation of hazardous/flammable goods areas (solvents and paints etc), hot work areas, tool storage, general working and storage areas.
- Development of, education and implementation of governance around the use of the facility. This should include:
 - Storage and use of solvents and paints
 - Leaving and usage of items left in the shared area.
 - Weekly or fortnightly clean and check of equipment.
- Long term solution is to replace the existing shipping containers and provide a load-supporting shade structure

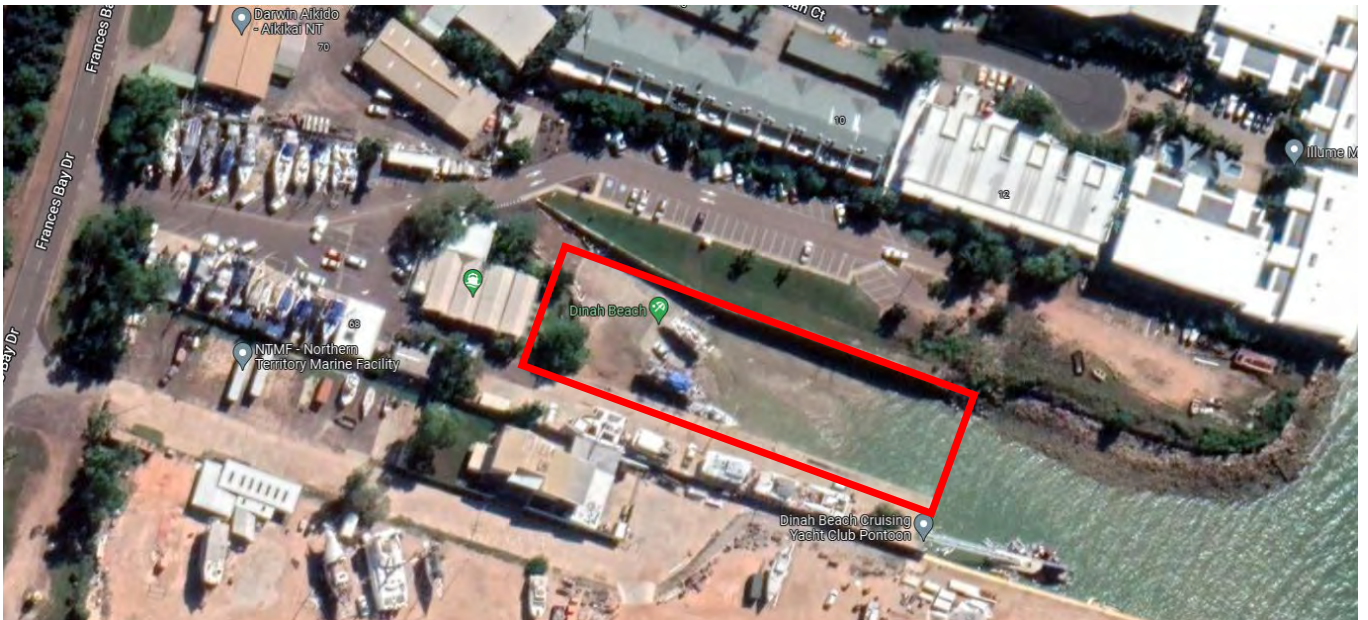
Figure 2 Berthing and Boat Ramp Location

Club members currently use private crane contractors to lift their boats out of the water for maintenance. The crane is normally positioned on the wharf adjacent the mooring pylons and the access ladders on the northern side of the boat ramp. This is a critical function of the Club and generates good revenue

The mooring pylons have recently been “refurbished” and in serviceable condition.

- The alfresco dining area retaining wall design be reviewed for functionality requirements by the Club, to refine the needs and constraints.
- Following confirmation of the retaining wall requirements, a re-design of the wall be undertaken, followed by market testing to understand budgetary needs for removal of the old wall and construction of the new wall.
- The concrete treatment be replaced with a purpose-designed boat ramp, complete with anti-slip/skid treatment for vehicular use.

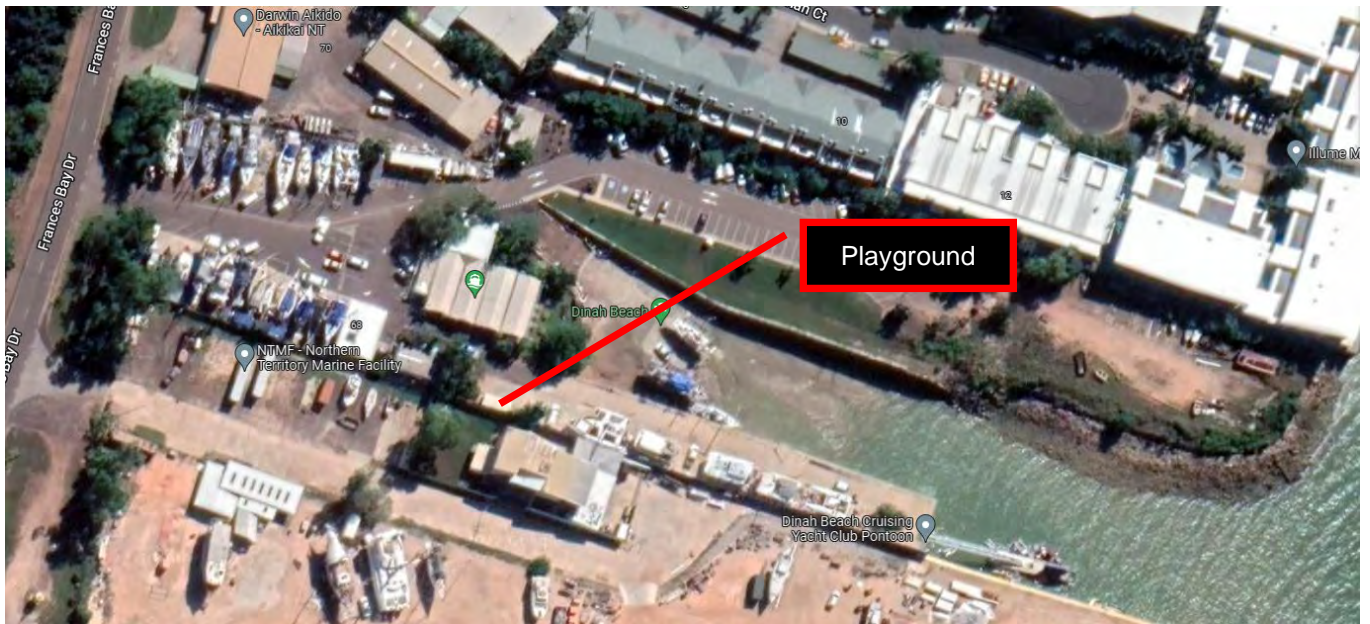
Figure 3 Playground Location

At time of inspection, it is not clear if the playground complies with relevant standards.

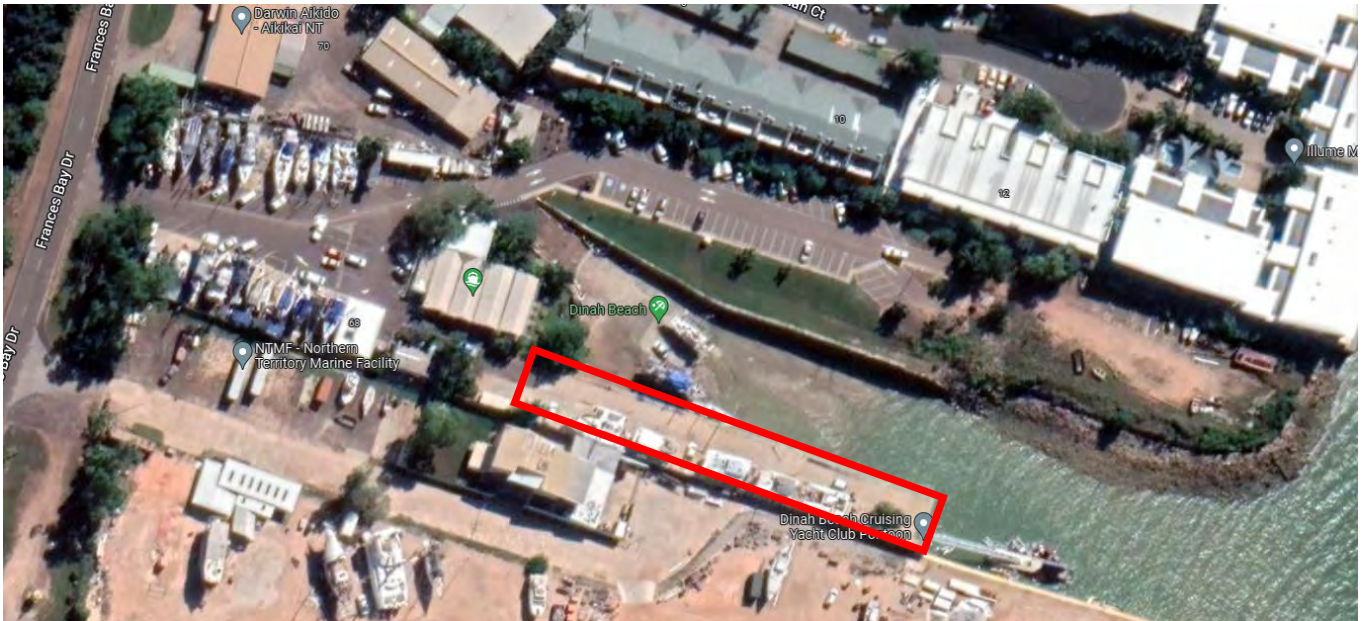
Figure 4 Concrete Wharf Location

- Little obvious designation was noted for activities such as lift zones, pedestrian movement, crane limits, emergency response gear (fire hydrant/s)
- Climbing ladders, wheel stops, and bollards don't appear fit-for-purpose
- There appears to be some longitudinal cracking and some very early evidence of concrete spalling in the concrete slabs.

- A further detailed people/safety compliance review be undertaken to identify for rectification those personnel safety items in order to minimise Club liability.
- General signage and line-marking improvements
- Replacement of the access ladders
- Suggest inspection by structural engineer be undertaken then potential additional investigation activities for the purpose of self-informing (not certification) could include:
 - Ground penetrating radar (quite cheap) to inform where low densities (cavities) may or may not exist
 - Survey surface (baseline for monitoring) and installation of movement gauges
 - More destructive investigation (core-drilling etc):
 - This process is unlikely to lead to a certification and is more a self-assurance outcome for the Club

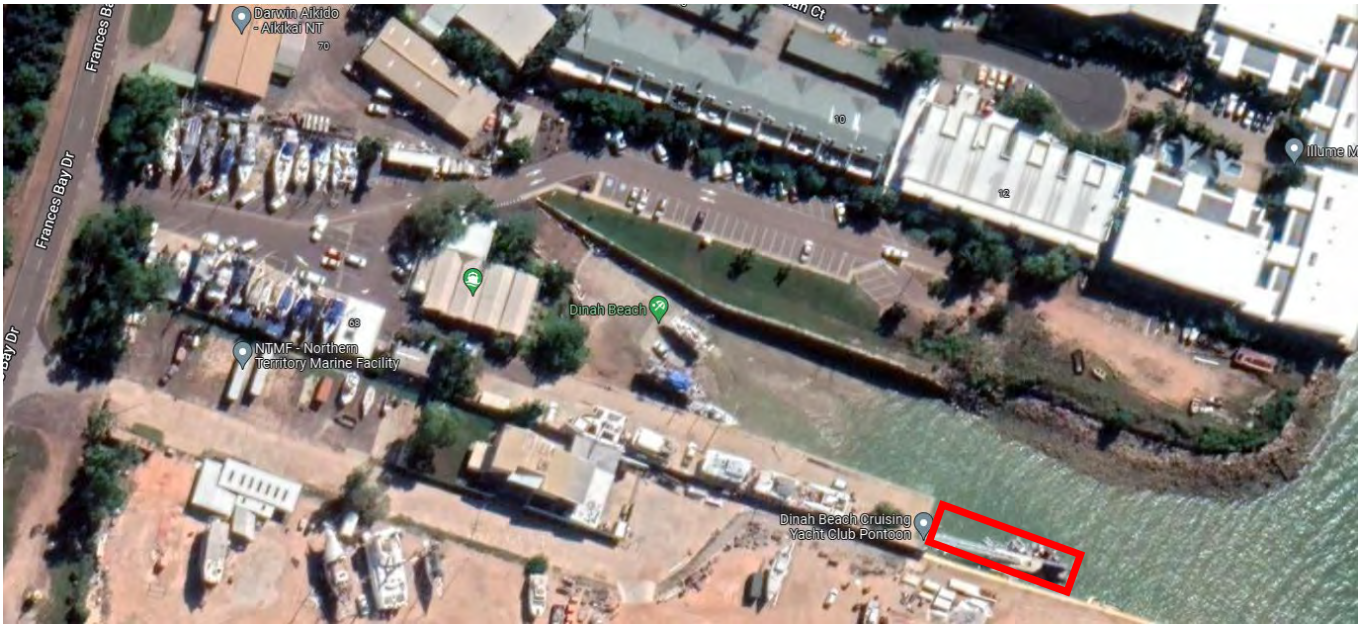
Figure 5 Pontoon Location

It appeared that there were conflicting views on the usability of the pontoon system through tidal movements and possibility of siltation incrementally reducing access for users.

- A detailed survey of the usability be undertaken with pontoon users to consolidate relevant themes to inform a forward plan of works.
- Rudimentary bathymetric measurements be undertaken to understand extent of siltation.
- Engagement of a suitable marine engineer to assess, scope and cost the replacement of the pontoons.

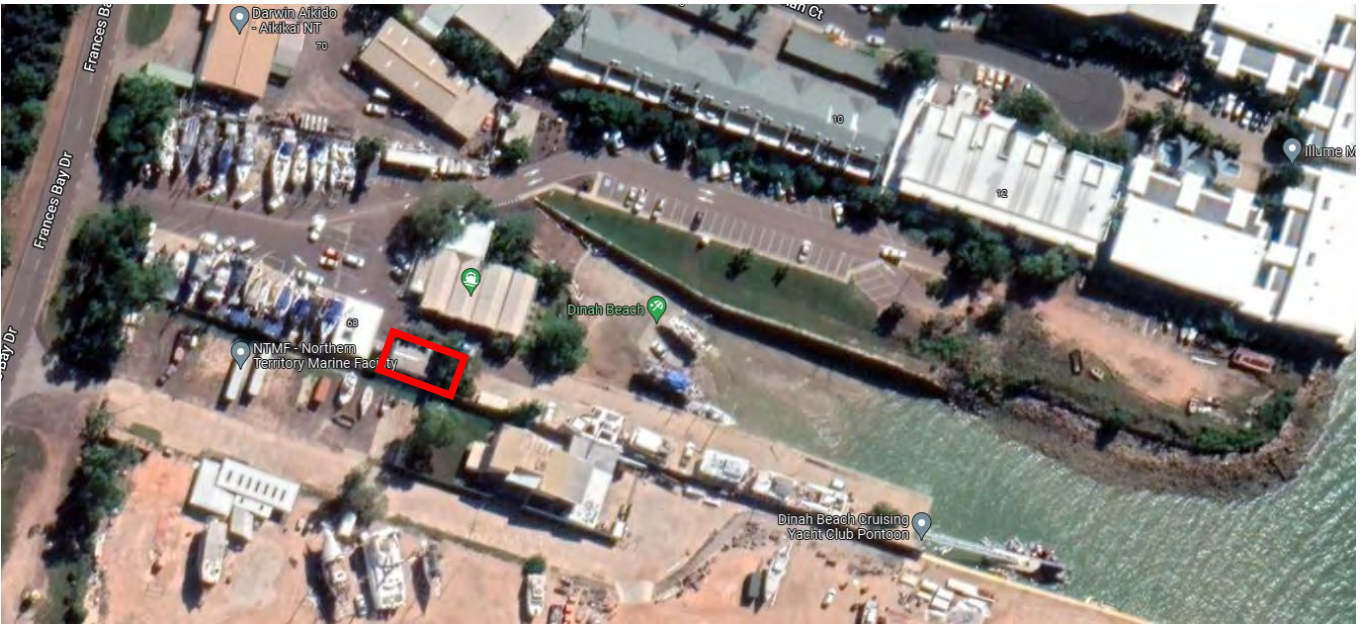
Figure 6 Kitchen Location

The internal aspects of the facility were not inspected during the site visit, however externally the building looks a poor condition and unlikely to meet safety compliance standards.

The kitchen presents an uncovered path between the alfresco eating area and the point of meal collection, creating a less comfortable patron experience during the wet season.

It is likely that a focussed architectural and compliance audit against Australian Standards and the Building Code of Australia would reveal significant issues.

It is recommended that the kitchen undergo an architectural and building code compliance assessment, after which the Club can determine appropriate next steps, timing and costs.

Whilst clearly the facility is serving a purpose currently, it is very likely that a full replacement of the facility will be required in the medium term.

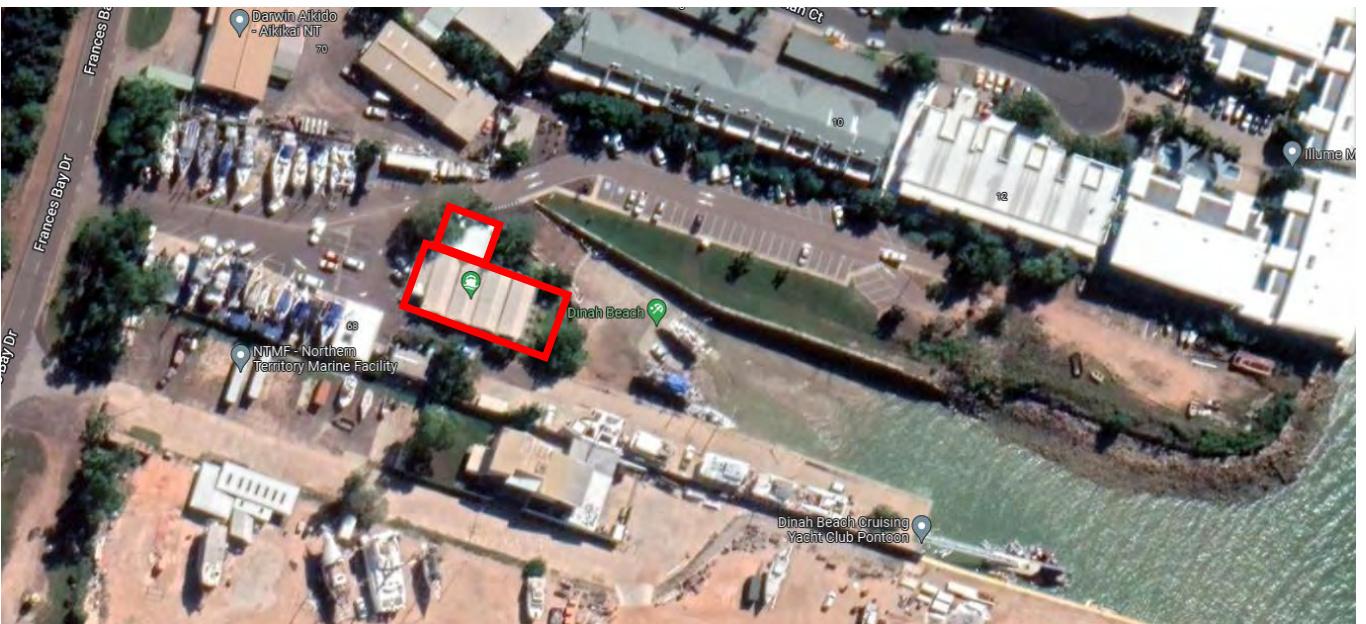
Figure 7 Bar and Alfresco area Location

The bar, cold storage and alfresco dining area provide a coastal, rustic feel to the patrons. The elements reflect the development of the area in stages, with perhaps less consideration of the overall planning, functionality and flow of the facility for employees and patrons.

- Complete a detailed architectural and building code compliance review of the facilities.
- Quote and subsequent replacement of the cool room flooring.

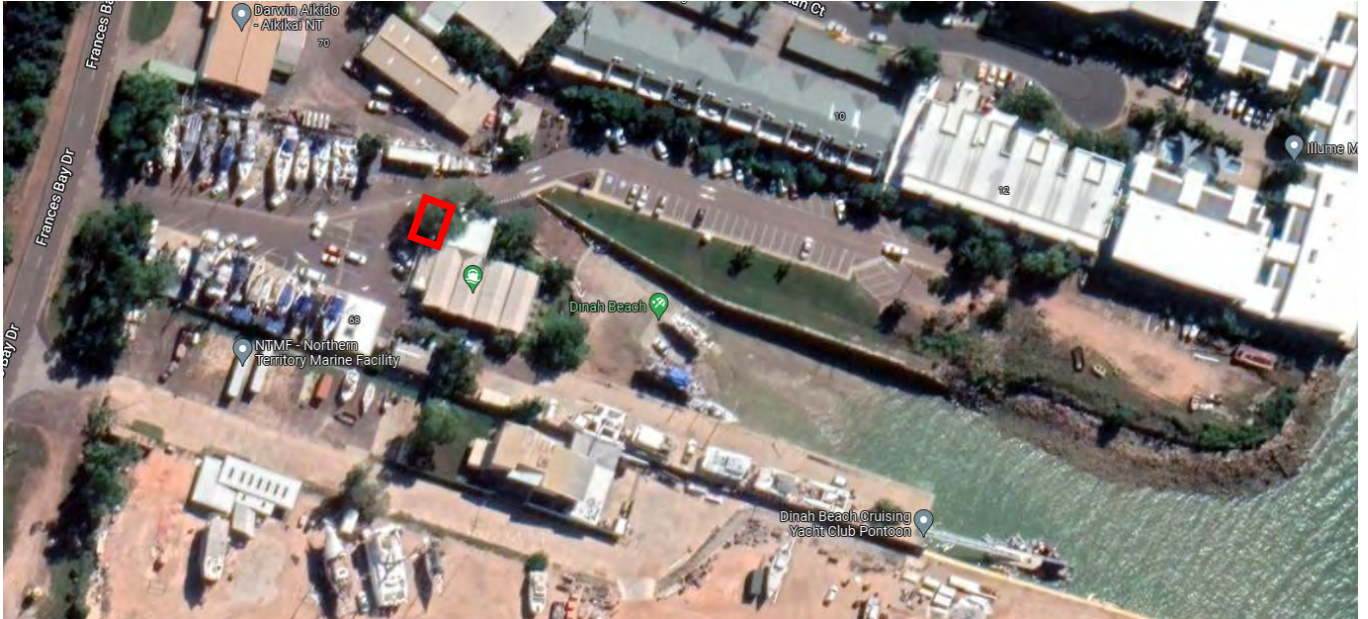
Figure 8 Office Location

The office is not fixed securely and would be susceptible to movement in the event of strong winds.

The entry/exit is via a door without landing or compliant steps.

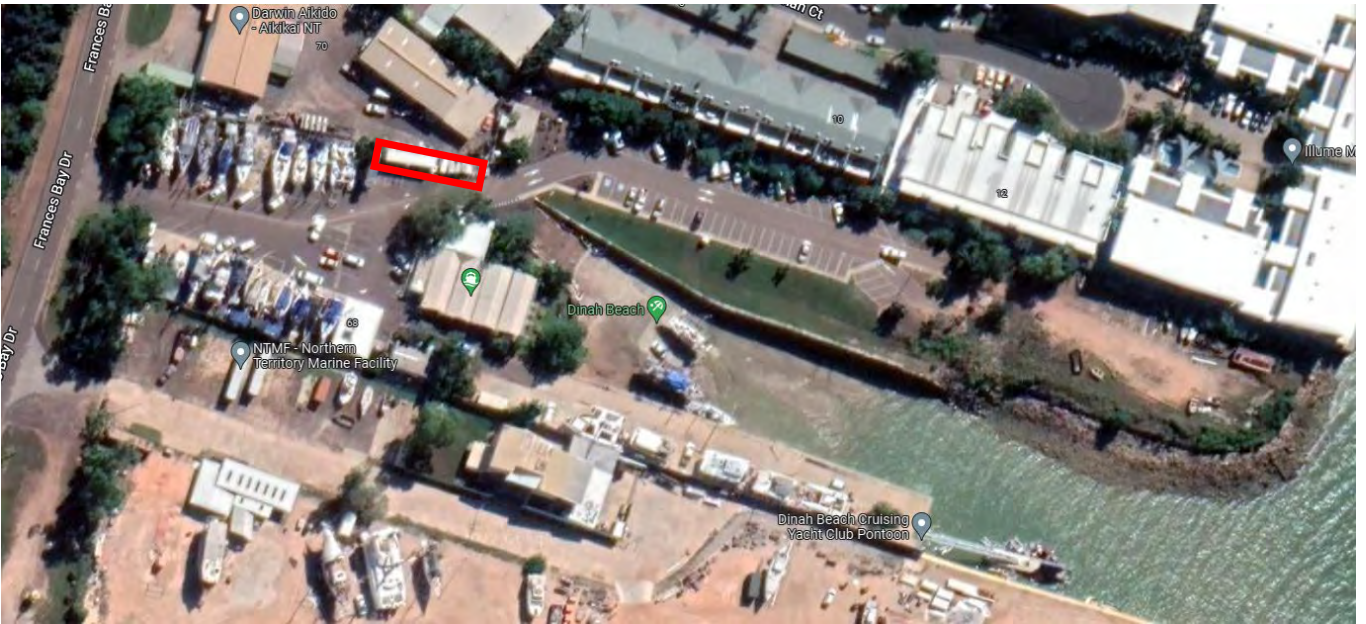
Figure 9 Waste Storage/Transfer facility Location

The observed usage shows mixed levels of compliance with appropriate separation of wastes, with opportunities to improve the compliance through increased signage, training, and governance.

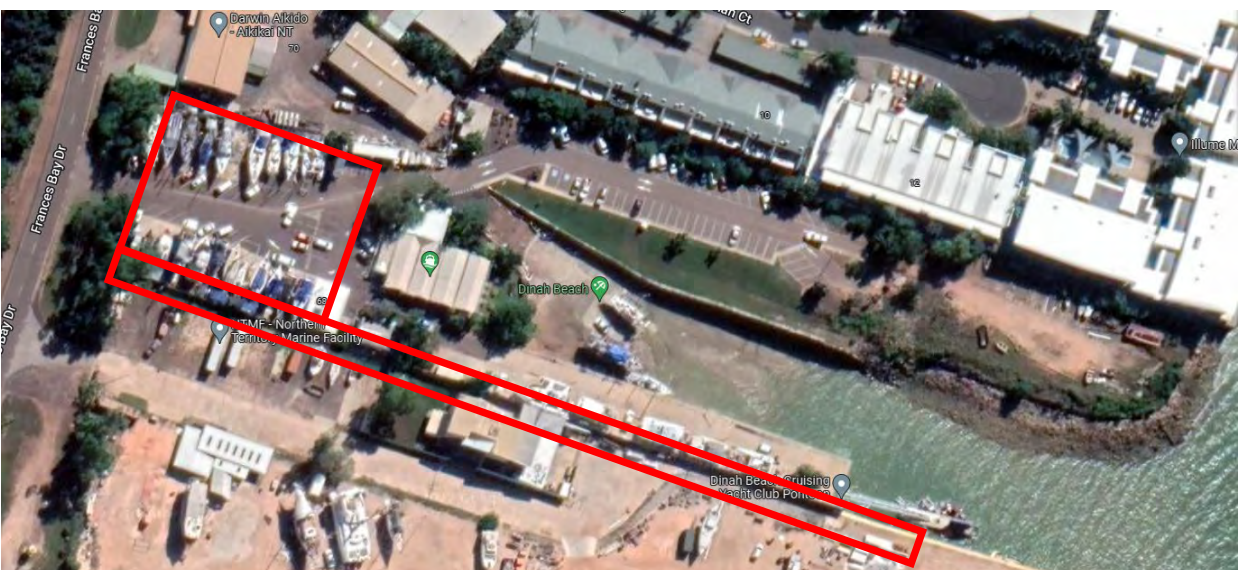
Figure 10 Boat Park Location

It is not known if there are any applicable standards pertaining to the compliance of the tying down of boats undergoing maintenance.

No recommendations.
